Coal Mine Fatal Accident 2007-05 & 06

Operator:	Tri-Star Mining, Inc.
Mine:	Job #3
Accident Date:	April 17, 2007
Classification:	Fall of Highwall
Location:	Dist. 3, Allegany County, Maryland
Mine Type:	Surface Coal Mine
Employment:	71
Production:	2,100 Tons/Day

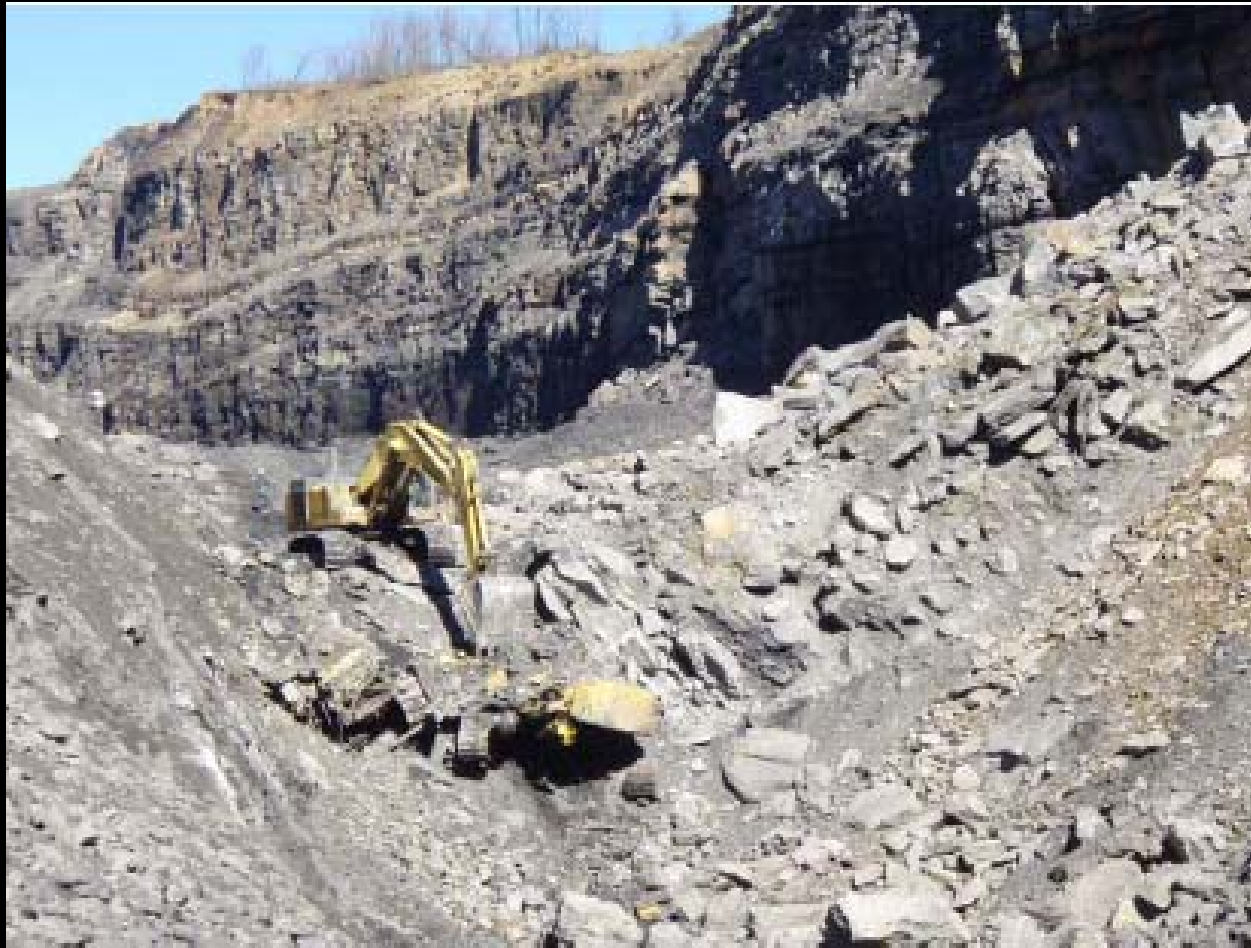
On Tuesday, April 17, 2007, a 51-year old excavator operator and a 38-year old bulldozer operator, with 15 years and 2 years of mining experience respectively, were fatally injured when a highwall failed. Both miners were operating equipment beneath the highwall portion that failed. The failure measured approximately 230 feet high, 240 feet wide, and 40 feet deep. The work was being performed near old underground mine works.
